Manhole Inspection Summary

Manhole # S15A1_011MH

Insp Date: **6/19/08 2:57 PM**

Location Address: **1410 st marks av**

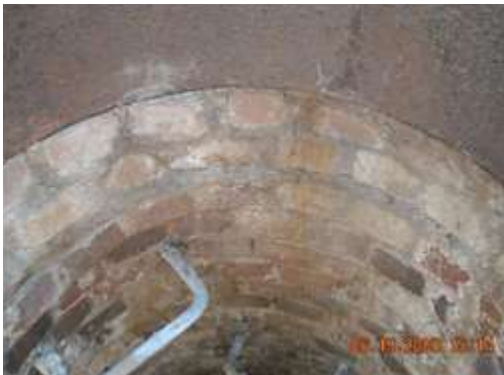
Defect 1

Infiltration: ☐ None ☐ Joint ☐ Cracks ☐ Mortar ☐ Roots ☒ **Wall**

Infiltration: ☐ None ☒ **Joint** ☐ Cracks ☐ Mortar ☐ Roots ☒ **Wall**

corbel and chimney infiltration

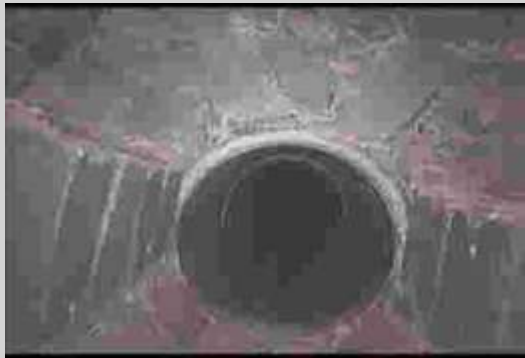
12 O'Clock Outflow

8 in. Circular Gravity Sewer
Pipe Out @ 12 O'Clock

Pipe Height: **8.4** (in.) Rod and Bar (Angled)
Pipe Material: **Clay** ☐ Pipe Lined
Invert Depth: **10.20** (ft.) Flow Characteristics: **Slow**
Deposits: ☒ None ☐ Mud ☐ Sludge ☐ Debris ☐ Grease
Silt Depth: **0** (in.) Deposits Extent:
Infiltration: **None** Pipe Seal Cond: **Sound**

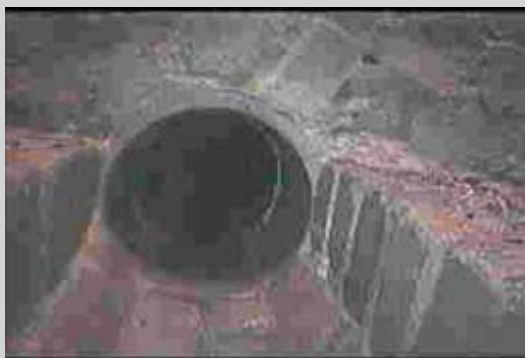
6 O'Clock Inflow

8 in. Circular Gravity Sewer
Pipe In @ 6 O'Clock

Pipe Height: **8.4** (in.) Rod and Bar (Angled)
Pipe Material: **Clay** ☐ Pipe Lined
Invert Depth: **9.85** (ft.) Flow Characteristics: **Slow**
Deposits: ☒ None ☐ Mud ☐ Sludge ☐ Debris ☐ Grease
Silt Depth: **0** (in.) Deposits Extent:
Infiltration: **None** Pipe Seal Cond: **Sound**
